SOLAR MALFUNCTION CASE STUDY

Rapid Detection of Solar Malfunction:
Preventing Weeks of Lost Generation

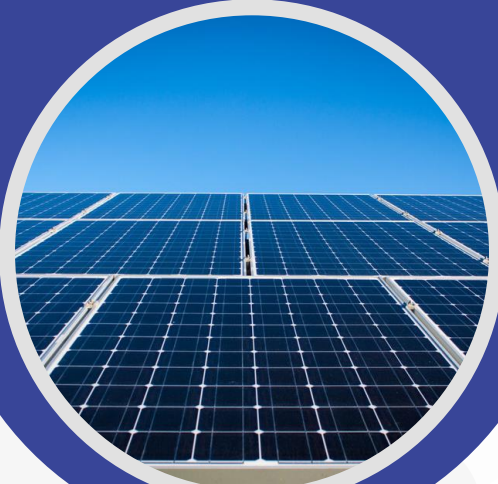
0 kWh

Solar Generation under Clear Skies risking weeks of lost generation

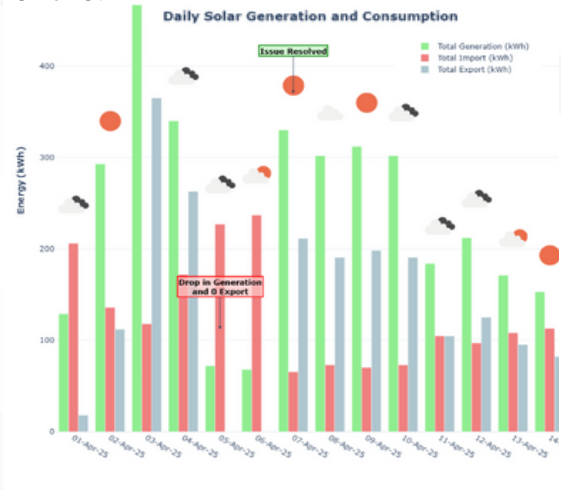
A hidden inverter fault caused internal DC currents to spike from ~30 A to 500 A and AC voltage on Phase A to leap from 250 V to over 6,000 V, well beyond safe limits. Because these electrical anomalies occurred inside the inverter, its own alarms never tripped—only OAK's external monitoring system detected and diagnosed the failure.

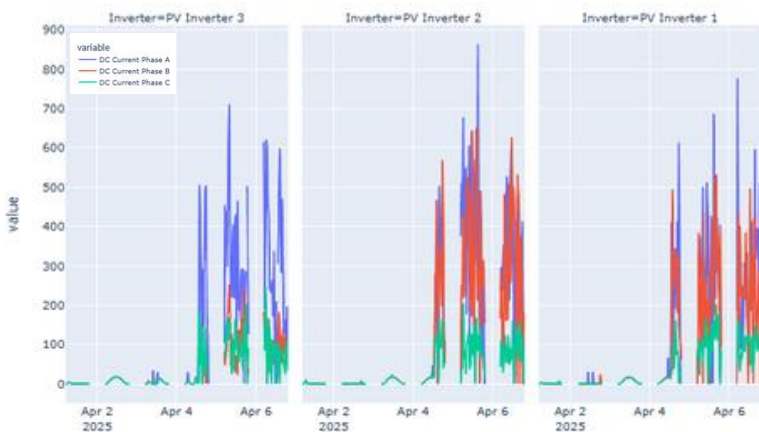
DC Current Spike:

Prior to 5th April, the three inverters operated normally, with DC currents averaging around 30 A. On 5th April, OAK's sensors detected a sudden surge to an average of 500 A, signaling a severe electrical fault inside the inverter system.

By continuously tracking these key electrical parameters, OAK's system flagged these critical outliers within hours — enabling technicians to target the precise failure point without delay. This real-time electrical insight was vital to the swift 2-day resolution and prevention of extended downtime.

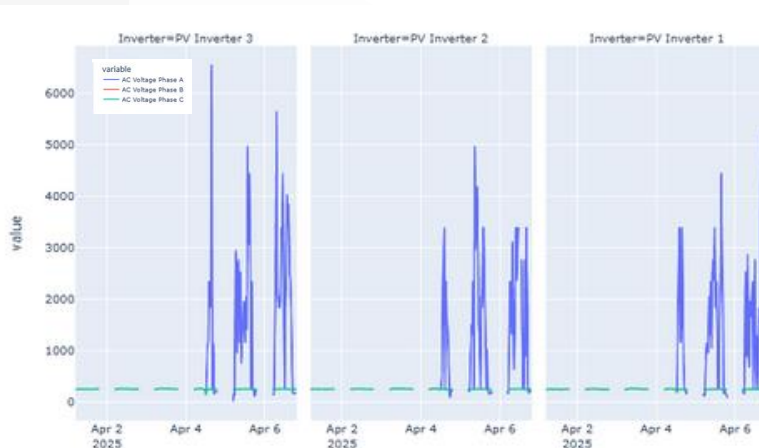
AC Voltage Abnormality:

Alongside this, the AC voltage on Phase A increased sharply from a stable average of 250 V to over 3000 V, peaking at 6550 V — values far beyond the equipment's normal operating range. This spike is a classic indicator of inverter malfunction or electrical isolation failure.
